Figure 1: Management Unit 8B (Pegwell Bay)

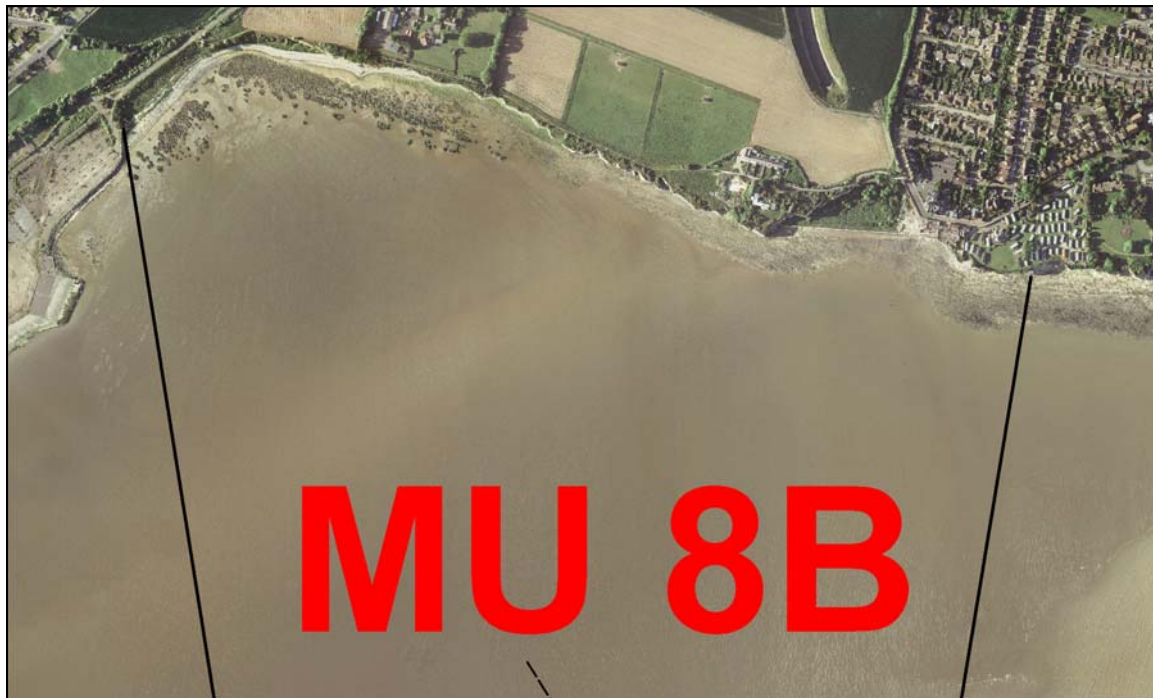
*Blue: Recycling Extraction Point*
Red: Recycling Deposition Area

The chalk cliffs in the east of this Management Unit give way to a small section of geologically important sandstone cliffs, and then to low-lying land in the west which has no primary defences. Fronting the low-lying agricultural land are tidal flats, which extend north of the River Stour and are of international nature conservation value.
