Figure 1: Management Unit 9C (St Margaret's at Cliffe)

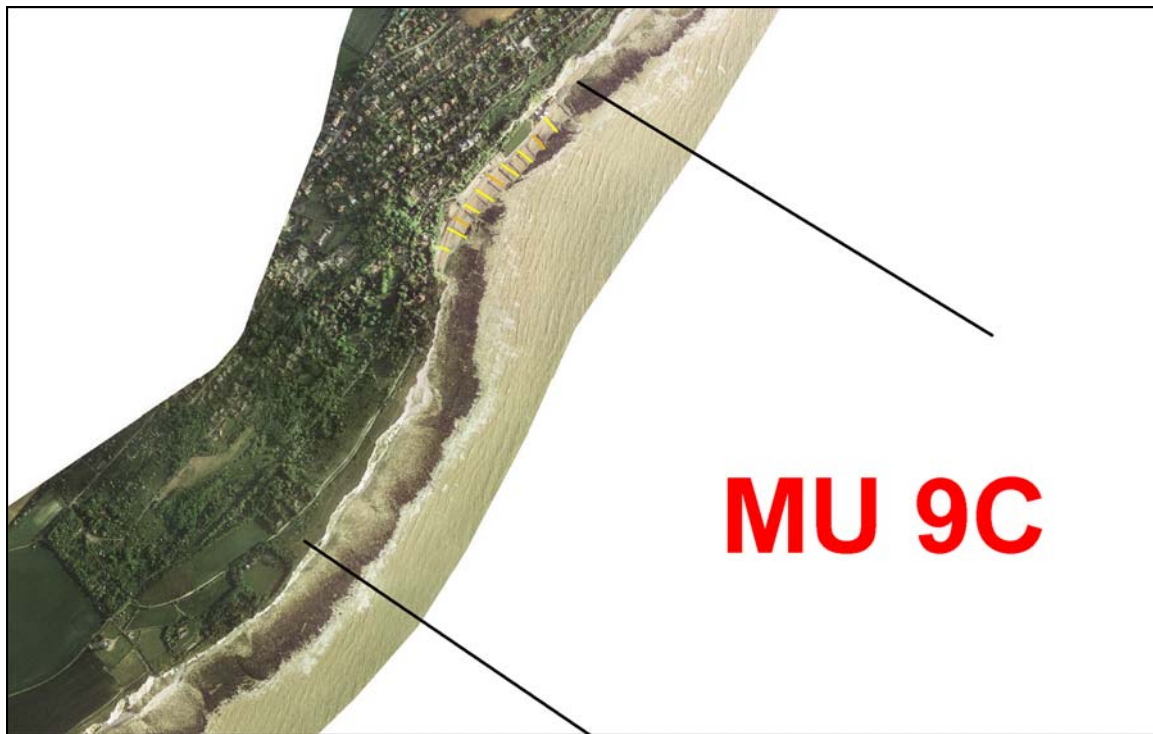
Blue: Recycling Extraction Point

Red: Recycling Deposition Area

This unit covers the section of coast which contains the cliff-top village of St Margaret's Bay as well as some development on the undercliff platform at the base of the cliffs. The frontage has a history of defence and currently there are a number of management practices in place. A mixed shingle beach comprising several timber groynes and a seawall act as protection to the cliff toe.
