Figure 1: Management Unit 28 (Sovereign Harbour)

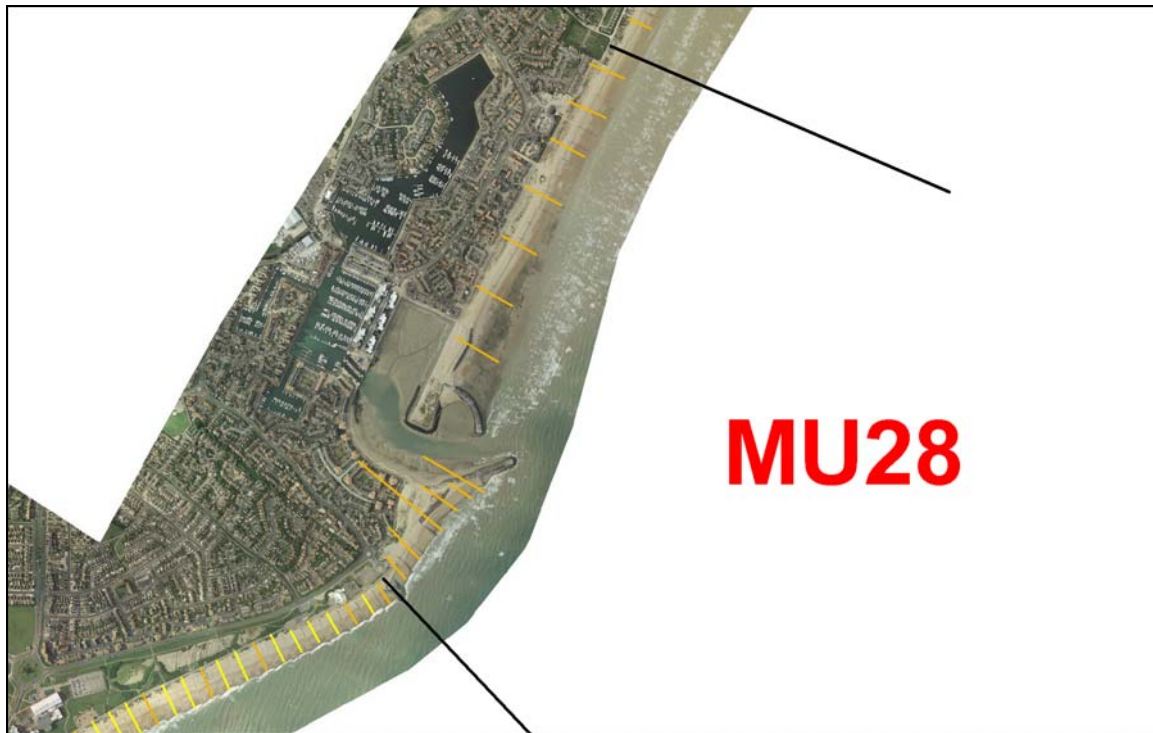
Blue: Recycling Extraction Point

Red: Recycling Deposition Area

The shingle beach is an important method of defence for Sovereign Harbour and its surrounding area. Residential buildings are in close proximity to the shoreline edge. A seawall is present for the southern section of the beach; however, this is short whereas at the northern end the residential property ends on the beach front. The main feature of this management unit is evidently the harbour itself, which causes sediment flow problems resulting in recycling works and dredging in and around the harbour.
