**Figure 1: Management Unit 01 (South Foreland)**

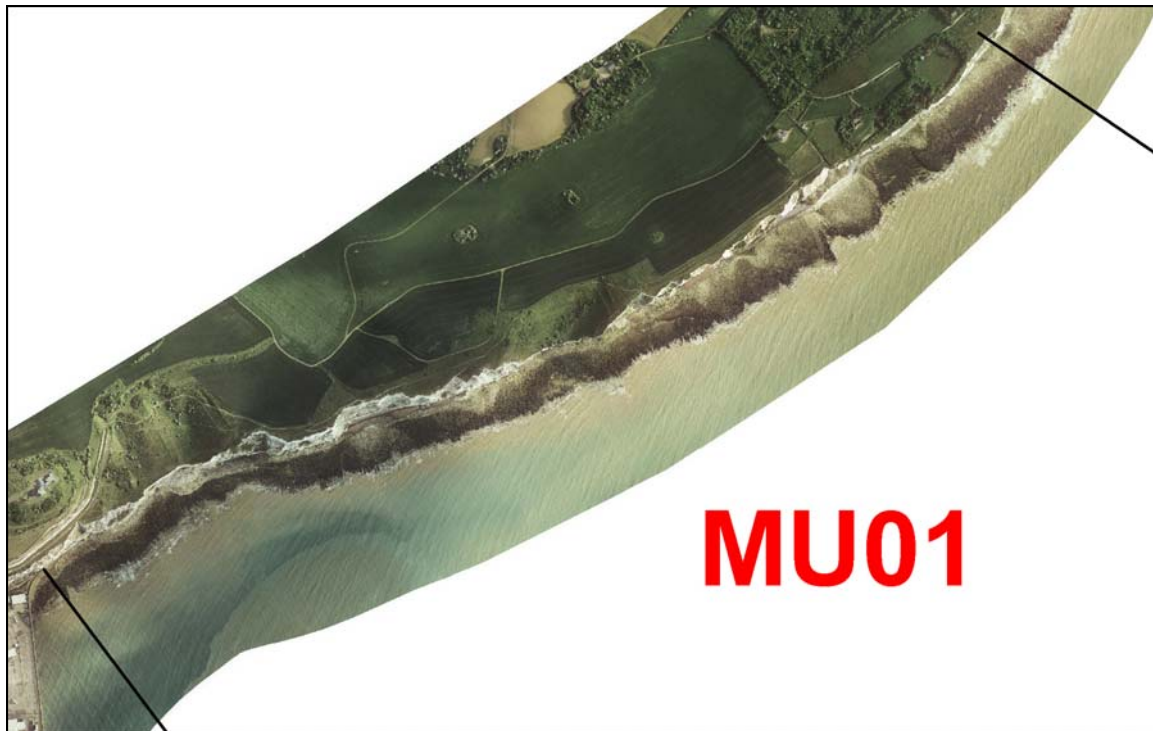
Blue: Recycling Extraction Point  
Red: Recycling Deposition Area

South Foreland marks the southern extremity of the Isle of Grain to South Foreland SMP frontage. The steep chalk cliffs, reaching 150m in height along this section of the coast, are unprotected and eroding. The foreshore comprises a chalk wave cut platform with varying accumulations of cliff fall debris. The cliffs are composed of Lower and Middle Chalk and because of this are able to maintain a steep cliff face. This area is of high nature conservation and landscape value, with little cliff-top development. The development of the Dover Harbour Arms has effectively cut off the longshore beach material supply. Drift is predominantly eastwards, although a very weak drift reversal from South Foreland to Dover does exist.

No recycling activities have been undertaken within this management unit as the long term plan is 'No Active Intervention', allowing continued cliff erosion, which will maintain the important geological and environmental interests of the frontage and its landscape quality.
