Figure 1: Management Unit 07 (Copt Point)

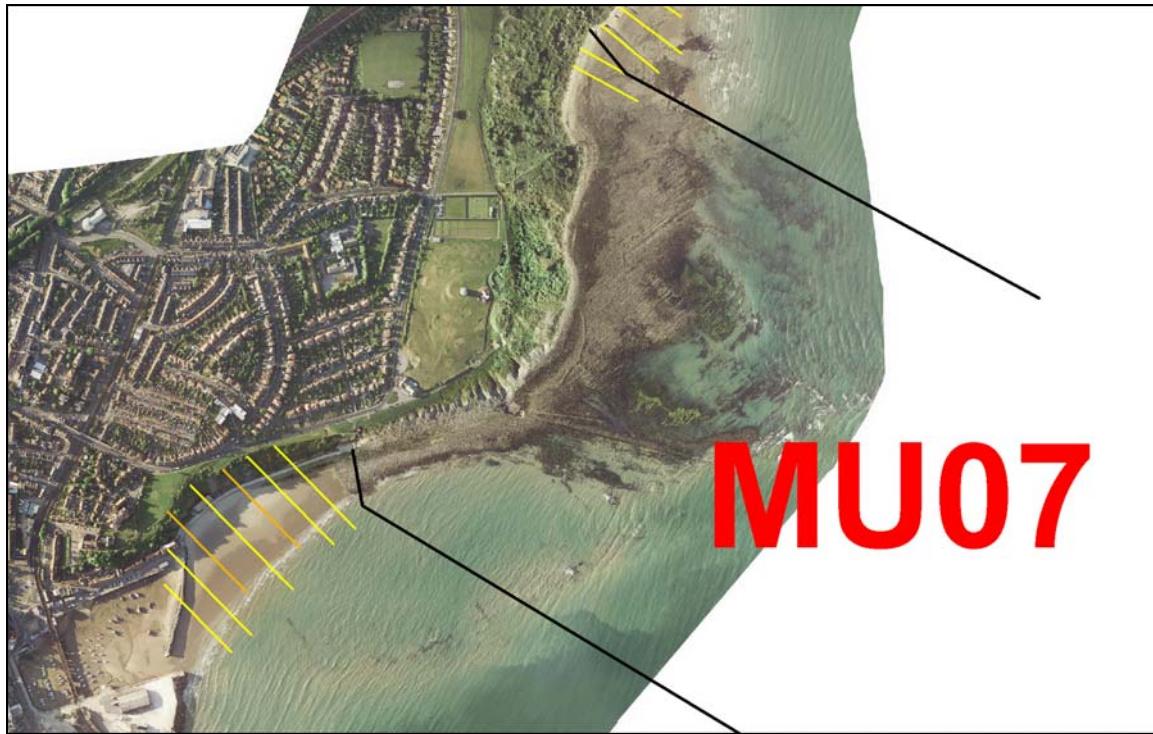
Blue: Recycling Extraction Point

Red: Recycling Deposition Area

Copt Point is an undefended section of coastline, primarily due to the area of open space on the cliff top. The natural defences are a result of previously slipped material which protects the cliff toe. Sea cliffs along the backshore are chalk and Gault Clay making the 160m high cliffs highly susceptible to major land sliding. The beach is primarily shingle with a sandy foreshore.
